# Fire risk assessment

Marsden Court

Marsden Court, Kettlemere Rise, TQ3 1WX

**DRAFT — not an approved issued version**

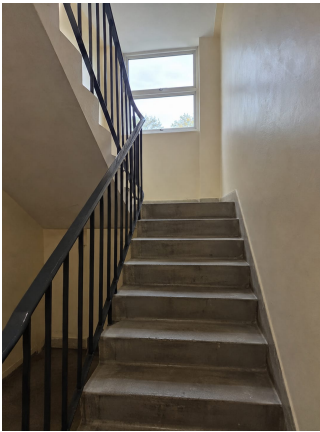
Communal stair

A resident's pushchair and folded cardboard were stacked in the ground-floor lobby opposite flat 2. No storage was recorded on the stair flights.

Stored items were present on escape-route areas despite the stair flights themselves being clear.

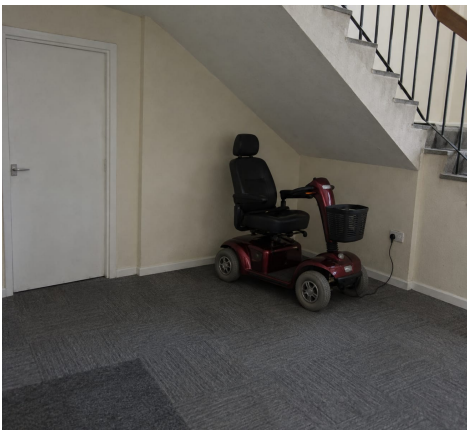
A mobility scooter and charger were stored on an escape route.

Mobility scooter on charge, ground-floor lobby

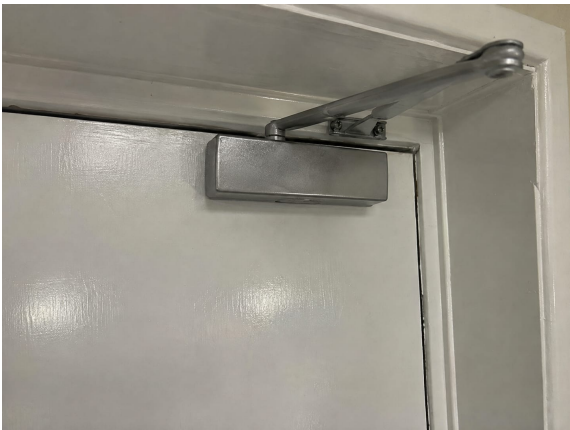
The communal entrance door closed and latched when observed.

Although no wedges were seen, the flat 2 entrance fire door did not remain closed when released.

Overhead self-closer, communal entrance door

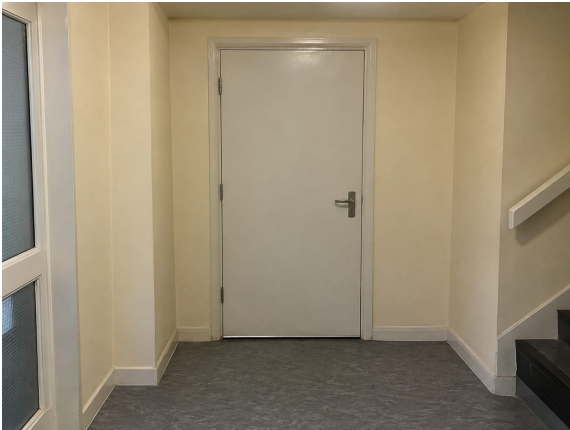
The self-closer to flat 2 did not work where checked, despite satisfactory recorded operation of other checked closers.

Ground-floor flat entrance door

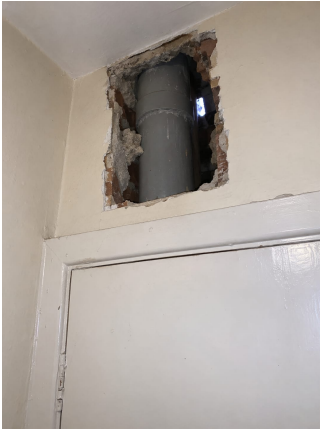
2nd floor lobby

At the second-floor lobby, an approximately 100 mm by 150 mm unsealed hole was observed around a pipe above the riser door.

A visual breach was observed in the wall at the second-floor riser location.

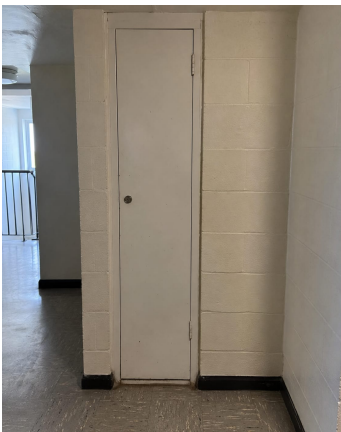
A service penetration at the second-floor riser was not fire-stopped where seen, while the first-floor riser cupboard interior was not inspected.

First-floor riser cupboard door

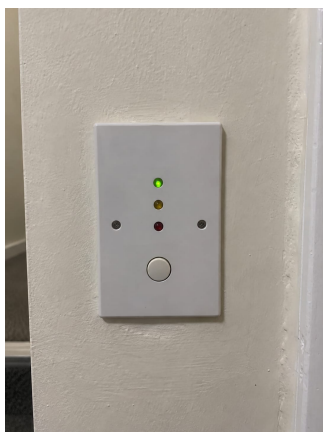
The first-floor AOV did not appear to operate on the recorded test.

Smoke control override panel, first-floor lobby

Investigate and restore the AOV so it opens and resets on test. Obtain current smoke-control service records and confirm failed AOVs are repaired.

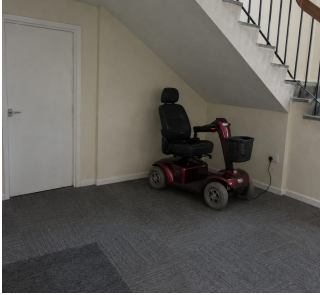
Mobility scooter on charge, ground-floor lobby

Proposed priority (assessor to confirm): High · Target: 7 days · Responsible: Hartlow Housing ·

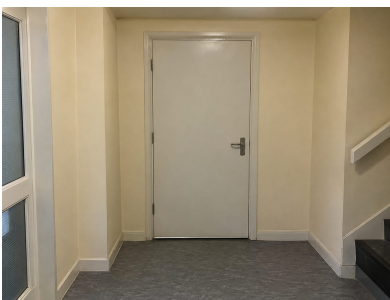
## 8. Flat 2 — self-closer disconnected and intumescent strip missing

Ground-floor flat entrance door

Proposed priority (assessor to confirm): High · Target: 7 days · Responsible: Hartlow Housing ·
